Wire-stem fretting and galvanic corrosion as an underrecognized cause of metallosis after hip arthroplasty: A rare case report

ABSTRACT

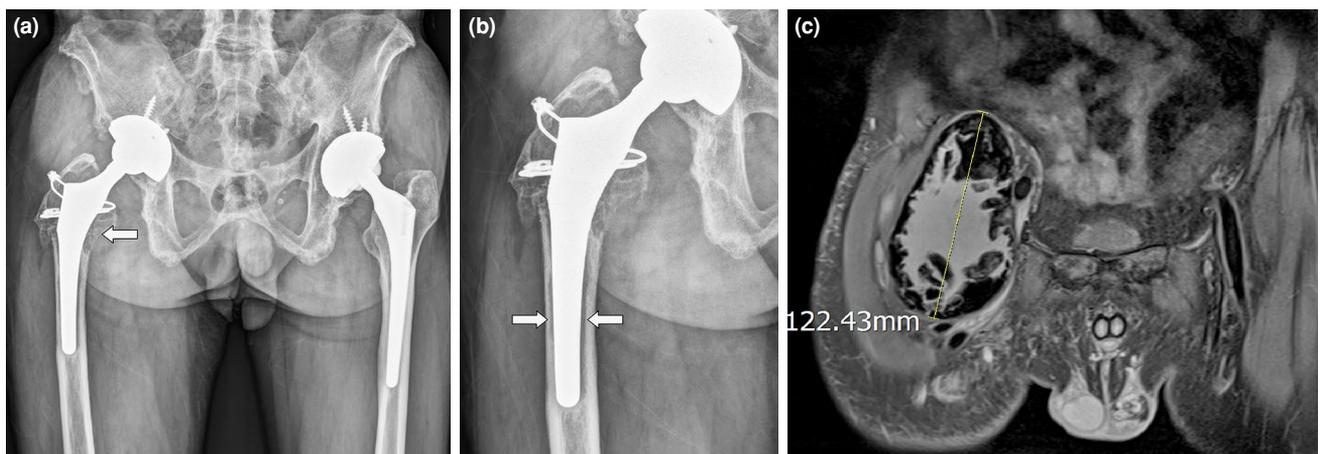
count of $7.48 \times 10^3/\mu\text{L}$, C-reactive protein (CRP) of 0.022 mg/dL, and erythrocyte sedimentation rate (ESR) of 2 mm/h, all within normal limits. Joint aspiration cultures were negative, leading to preliminary exclusion of periprosthetic joint infection. With infection preliminarily excluded, subsequent imaging studies were performed to explore alternative causes. Pelvic anteroposterior radiograph demonstrated the right femoral stem with a cerclage wire encircling the proximal femur (Figure 1a). A low-density lesion was observed in the trochanteric region, raising suspicion for an adverse tissue response, possibly due to metallic debris released from micro-motion-induced fretting at the wire-stem interface. A magnified anteroposterior view of the right hip further showed radiolucent lines along the stem-bone interface adjacent to the proximal cerclage, raising radiographic signs suggestive of loosening (Figure 1b). Magnetic resonance imaging (MRI) revealed an approximately 12-cm cystic lesion with solid components, adjacent to the femoral stem, with T2 hyperintensity and thick rim enhancement, without evidence of sinus tract or abscess formation (Figure 1c). These findings raised concern for an ALTR, and revision surgery was undertaken through a posterolateral approach.

Intraoperatively, gray-black stained tissue was sharply localized at the cerclage wire-stem interface along the medial aspect of the proximal femur, while the bearing couple and the head-neck taper showed no visible damage or discoloration. The femoral stem was grossly loose, and its proximal surface adjacent to the cerclage was contaminated by corrosion

FIGURE 1. Anteroposterior radiograph. (a) A cerclage wire encircles the proximal femur, and a low-density lesion is visible in the trochanteric region adjacent to the cerclage wire (arrow). (b) Radiolucent lines are visible along the stem-bone interface (arrows), suggestive of loosening. (c) T2-weighted MRI of the right hip showing a large cystic lesion with solid components (122.43 mm) with high T2 signal intensity is visible within the proximal thigh musculature.

products. After extensive debridement, the stem was replaced with a long, distally fixed femoral component to remove all potentially involved interfaces and minimize the risk of recurrent metallosis. During the operation, the proximal femur showed marked osteopenia. After removal of the femoral stem, a lateral cortical crack was identified, which might have compromised proximal

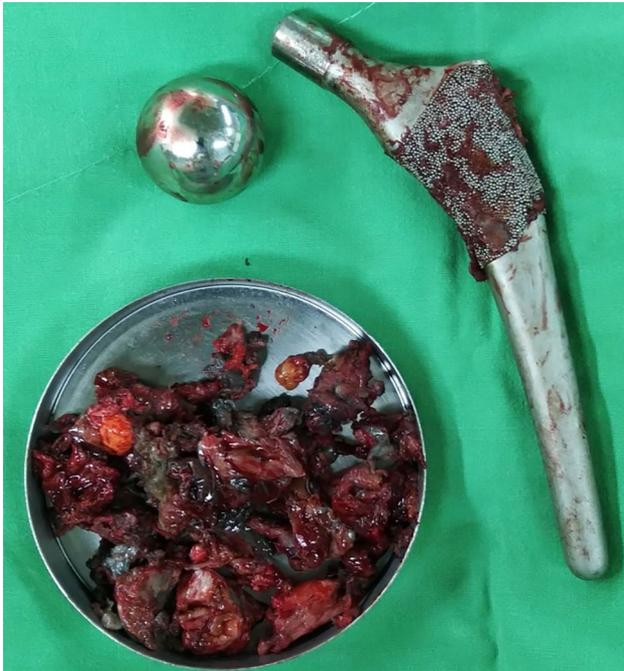
FIGURE 2. Excised metallosis-involved tissue and retrieved implants. Gross specimens show excised black-stained periprosthetic soft tissue together with the retrieved loosened femoral component.

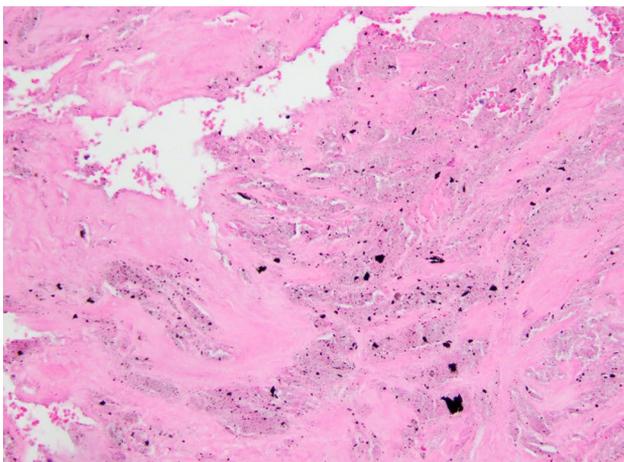
FIGURE 3. Hematoxylin and eosin staining of excised tissue. The section shows black metallic particles scattered within the interstitial tissue and within macrophages (H&E, $\times 200$).

implants. Postoperatively, histological examination of the excised tissue revealed fibroadipose tissue with chronic inflammation, macrophages containing refractile metallic particles, and multinucleated giant cells, while Gram stain and cultures were negative (Figure 3). At six months of follow-up, his pain score on the Visual Analog Scale (VAS) improved from a pre-revision value of 5 to 1, and his Harris Hip Score (HHS) increased from 70 to 93. Post-revision radiographs showed a well-seated femoral stem, in which the wire construct and cerclage were separated from the stem by intervening host bone (Figure 4). No progressive osteolysis was observed. A written informed consent was obtained from the patient.

Phagocytosis of metallic particles by macrophages triggers cytokine-mediated inflammation, which is central to ALTR, osteolysis, and periprosthetic bone loss.^[1,17] Histological examination of periprosthetic tissue from this patient demonstrated black, refractile metallic particles within the macrophages, accompanied by multinucleated giant cells (Figure 3), consistent with an ALTR pattern. Clinically, ALTR commonly presents with groin pain and restricted range of motion and may be accompanied by radiographic peri-implant radiolucency (i.e., periprosthetic osteolysis). Our patient did report groin pain and had a focal peri-stem low-density lesion on plain radiographs (Figure 1). Furthermore, MRI revealed a cystic lesion with solid components, aligning with the established ALTR-osteolysis phenotype. Taken together, these clinicopathologic and radiographic findings supports metallic debris-driven ALTR with focal osteolysis. In conjunction with the intraoperative distribution of black-stained tissue, these results suggest that the corrosive process may have originated at the proximal cerclage-stem interface, where micromotion and dissimilar metal contact could have interacted to drive the local reaction.

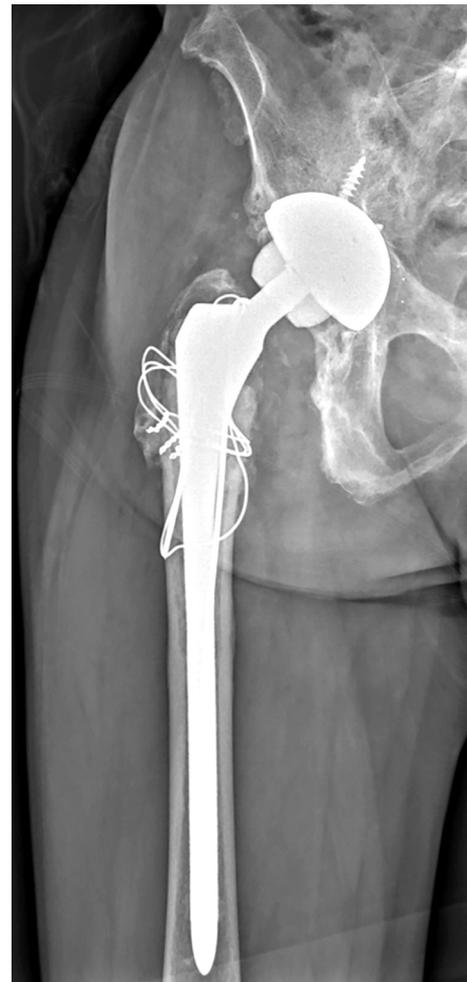
FIGURE 4. Post-revision anteroposterior radiograph. The image demonstrates a long, distally fixed stem. The tension band wiring construct and the cerclage wire are isolated from the stem by intervening host bone, with no direct metal-to-metal contact.

fixation of the femoral stem. To prevent further propagation of the crack and to reinforce proximal stability, a tension band wiring construct consisting of two Kirschner wires with proximally bent hooks and a tensioned figure-of-eight wire was applied, followed by placement of a stainless-steel cerclage wire circumferentially for additional reinforcement. The wire construct was positioned around the outer cortical surface, completely enclosing the stem, which ensured that no direct metal-to-metal contact occurred. The acetabular metal cup was retained, and the polyethylene liner was renewed to improve long-term durability. Figure 2 shows the excised metallosis-involved soft tissue and retrieved
