Intrapelvic protrusion of the ceramic head resulting from forte ceramic liner fracture without a significant trauma: a case report

Halil İbrahim Bekler, M.D., Yiğit Erdağ, M.D., Murat Özşahin, M.D.

Department of Orthopedics and Traumatology, Dr. Lütfi Kırdar Kartal Training and Research Hospital, İstanbul, Turkey

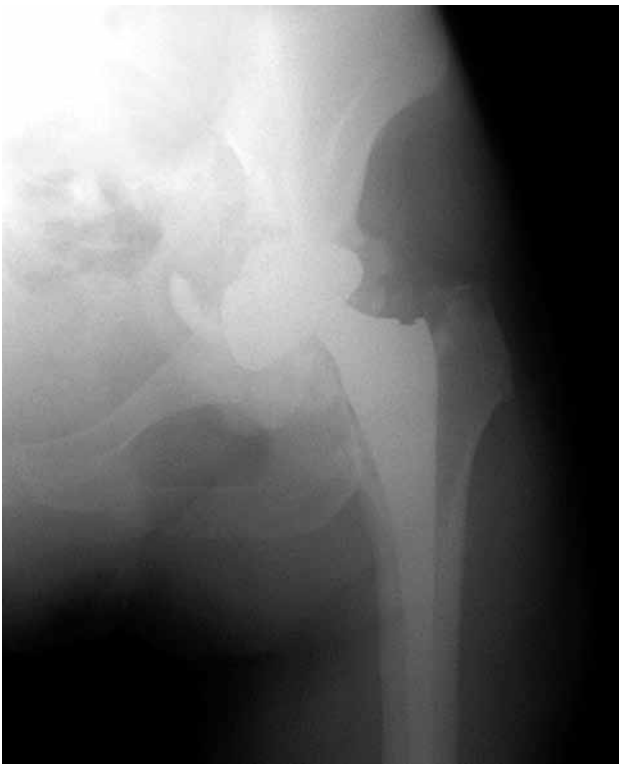
Figure 1. Preoperative radiographic view of the hip.

the operated side were revealed. On radiographic examination of the hip, an uncemented THA with a well-fixed femoral stem and failure of the acetabular component with protrusion into the pelvis were seen (Figure 1). The acetabular shell was completely disturbed by the femoral head and neck being displaced into the shell, with a fracture of the acetabular wall. The pelvic ring had lost its continuity, and broken ceramic components of the

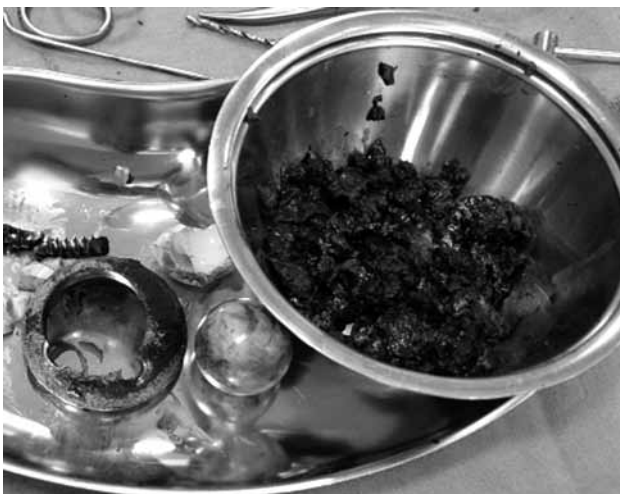
Figure 2. The entire wound was covered with black-colored tissue, extensive metallosis.

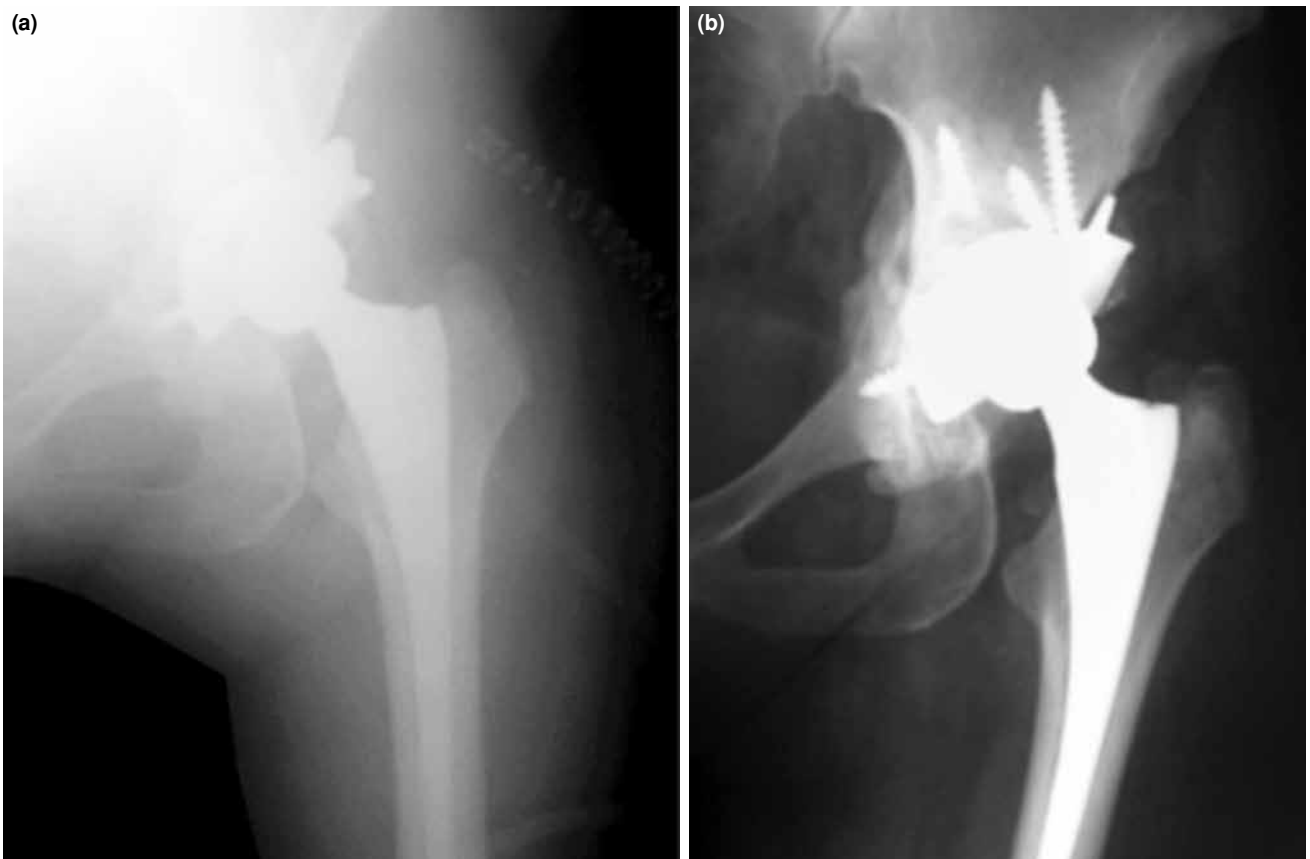
it seemed well-fixed. A new, reinforced stainless-steel femoral head was used to replace the damaged femoral head. The patient had an uneventful recovery and had no pain at the hip at the most recent follow-up examination at 15 months. The patient was able to return to full activity without any discomfort in the hip. The acetabular grafts healed well and the acetabular and femoral components were well-fixed (Figure 4a, b).

Figure 4. (a) Revision of early postoperative radiograph. (b) The first year postoperative radiograph.
